U.S. DEPARTMENT OF
ENERGY

July 14 Storm Damage Summary

Quarterly Public Meeting

August 26, 2015

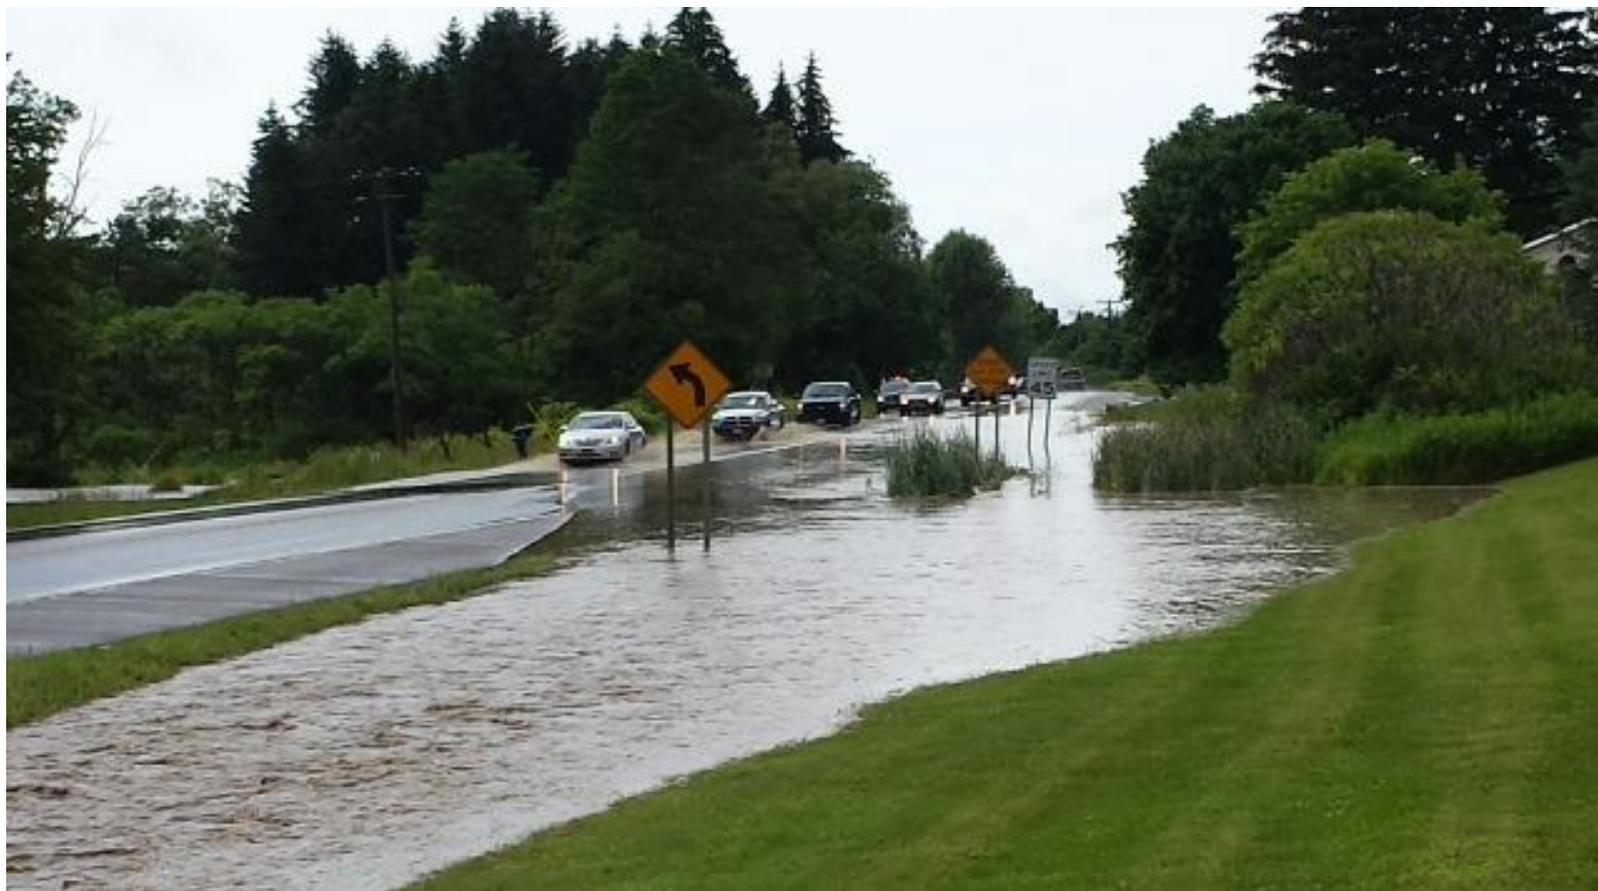
Route 219 in Front of the AOC

- On July 15, 2015, CHBWV, DOE, New York State Energy Research and Development Authority (NYSERDA) and the New York State Department of Environmental Conservation (NYSDEC) walked down the storm-affected areas including:
 - Lake 1 Spillway
 - Security fence undermining from off-site storm flow
 - HLW Haul Road crossing at Erdman Brook
 - Parshall flume area debris accumulation
 - S-09 Outfall
 - NYSERDA Erdman Brook and the Franks Creek plunge pools (Lee Gordon will present updates on behalf of NYSERDA)
- The Engineer of Record and two CHBWV employees also conducted a site visit to inspect the dam system spillway erosion

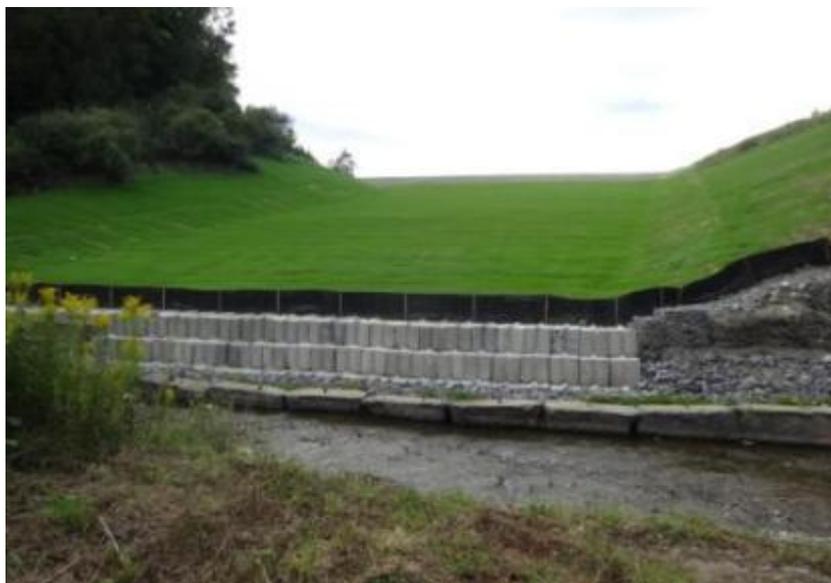
Lake 1 Spillway Before the Storm

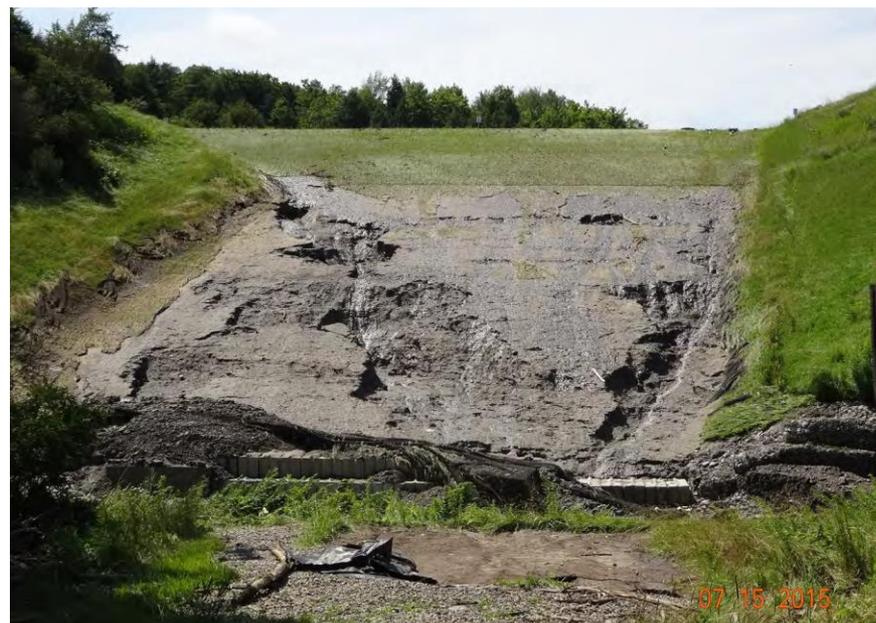
- A topographic survey of the Lake 1 Spillway was performed to capture current condition and plans for short-term clean-up response actions
- Engineer of Record reported no immediate threat to Lake 1 Spillway or Lake 1 Dam

Lake 1 Spillway After the Storm

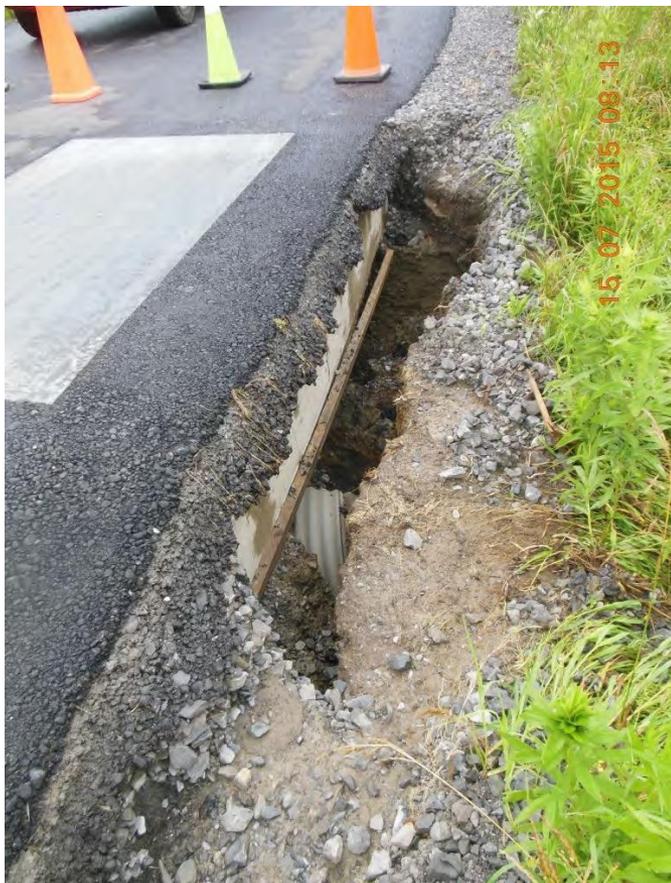
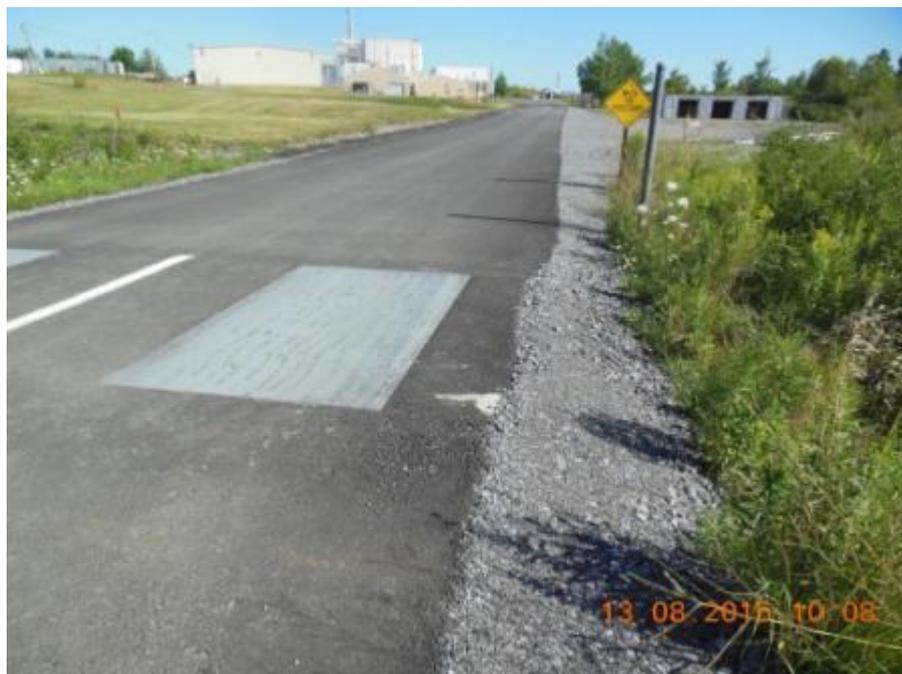
High-Level Waste Haul Path

- On July 15, the extent of damage under the Haul Road in the Erdman Brook area was evaluated
- Haul Path erosion damage caused by heavy rains the previous week were repaired on July 17

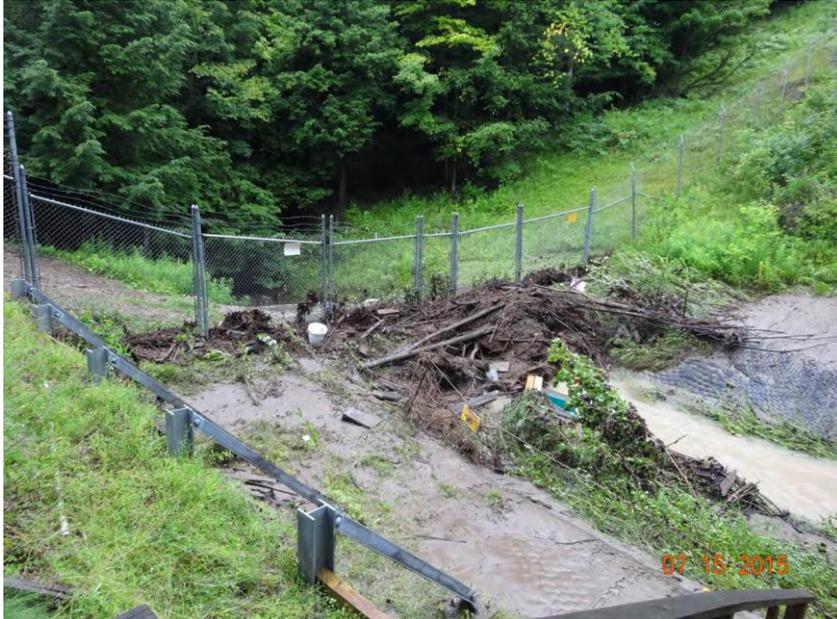
Erosion occurred upstream of the Parshall Flume (located in Franks Creek) with debris accumulation at discharge pipes in Parshall Plume cleared; debris must be cleared

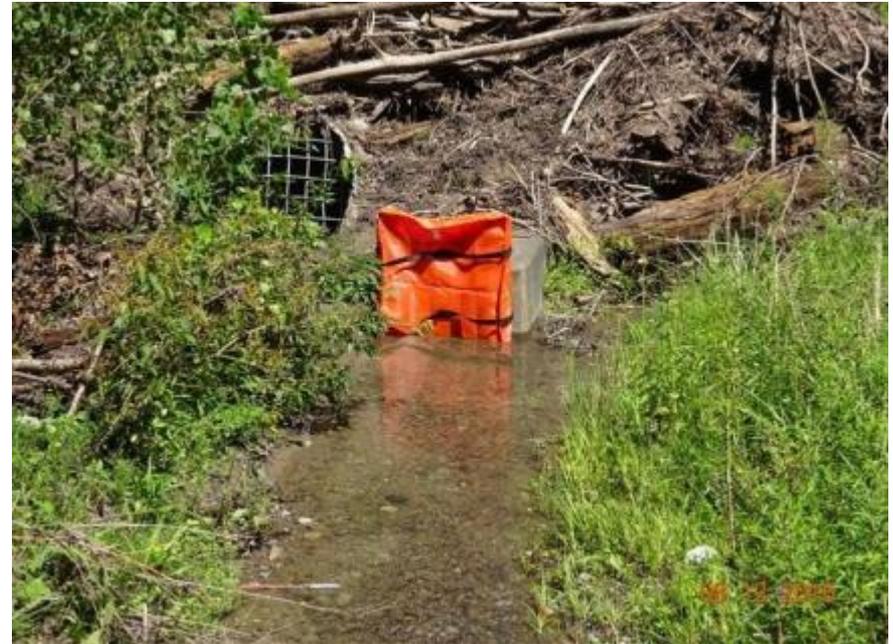
Existing S-09 Discharge

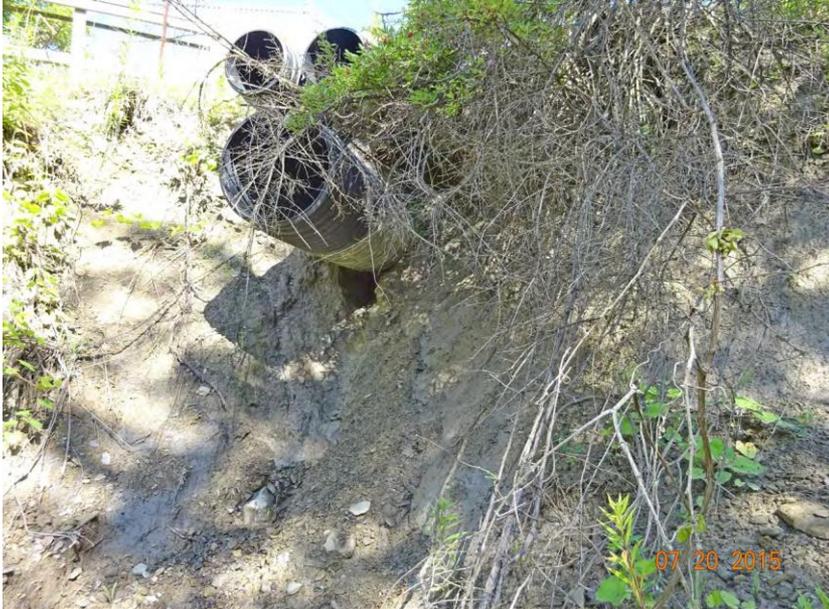
**Additional Erosion of S-09 Discharge Pipes
Caused by the Storm**

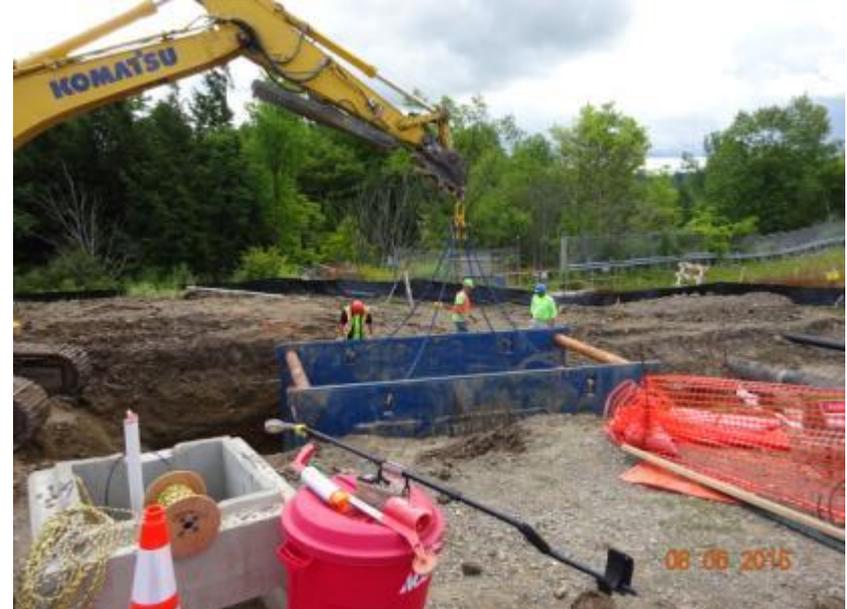
**Progress Continued with the Storm Water Outfall
Relocation Project**
